DEEL LAKE DAM

SHANNON COUNTY, MISSOURI

MO 31064

PHASE 1 INSPECTION REPORT NATIONAL DAM SAFETY PROGRAM

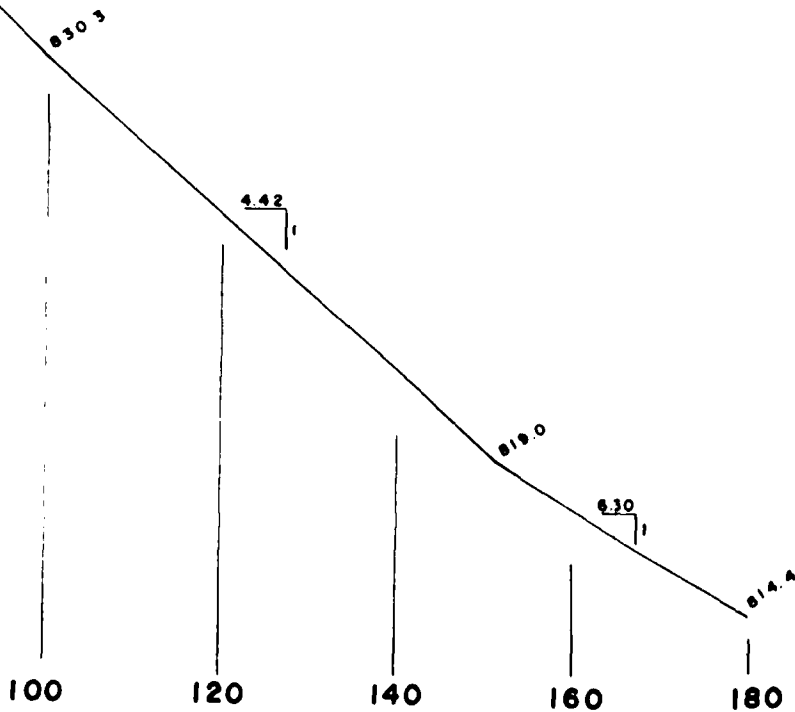
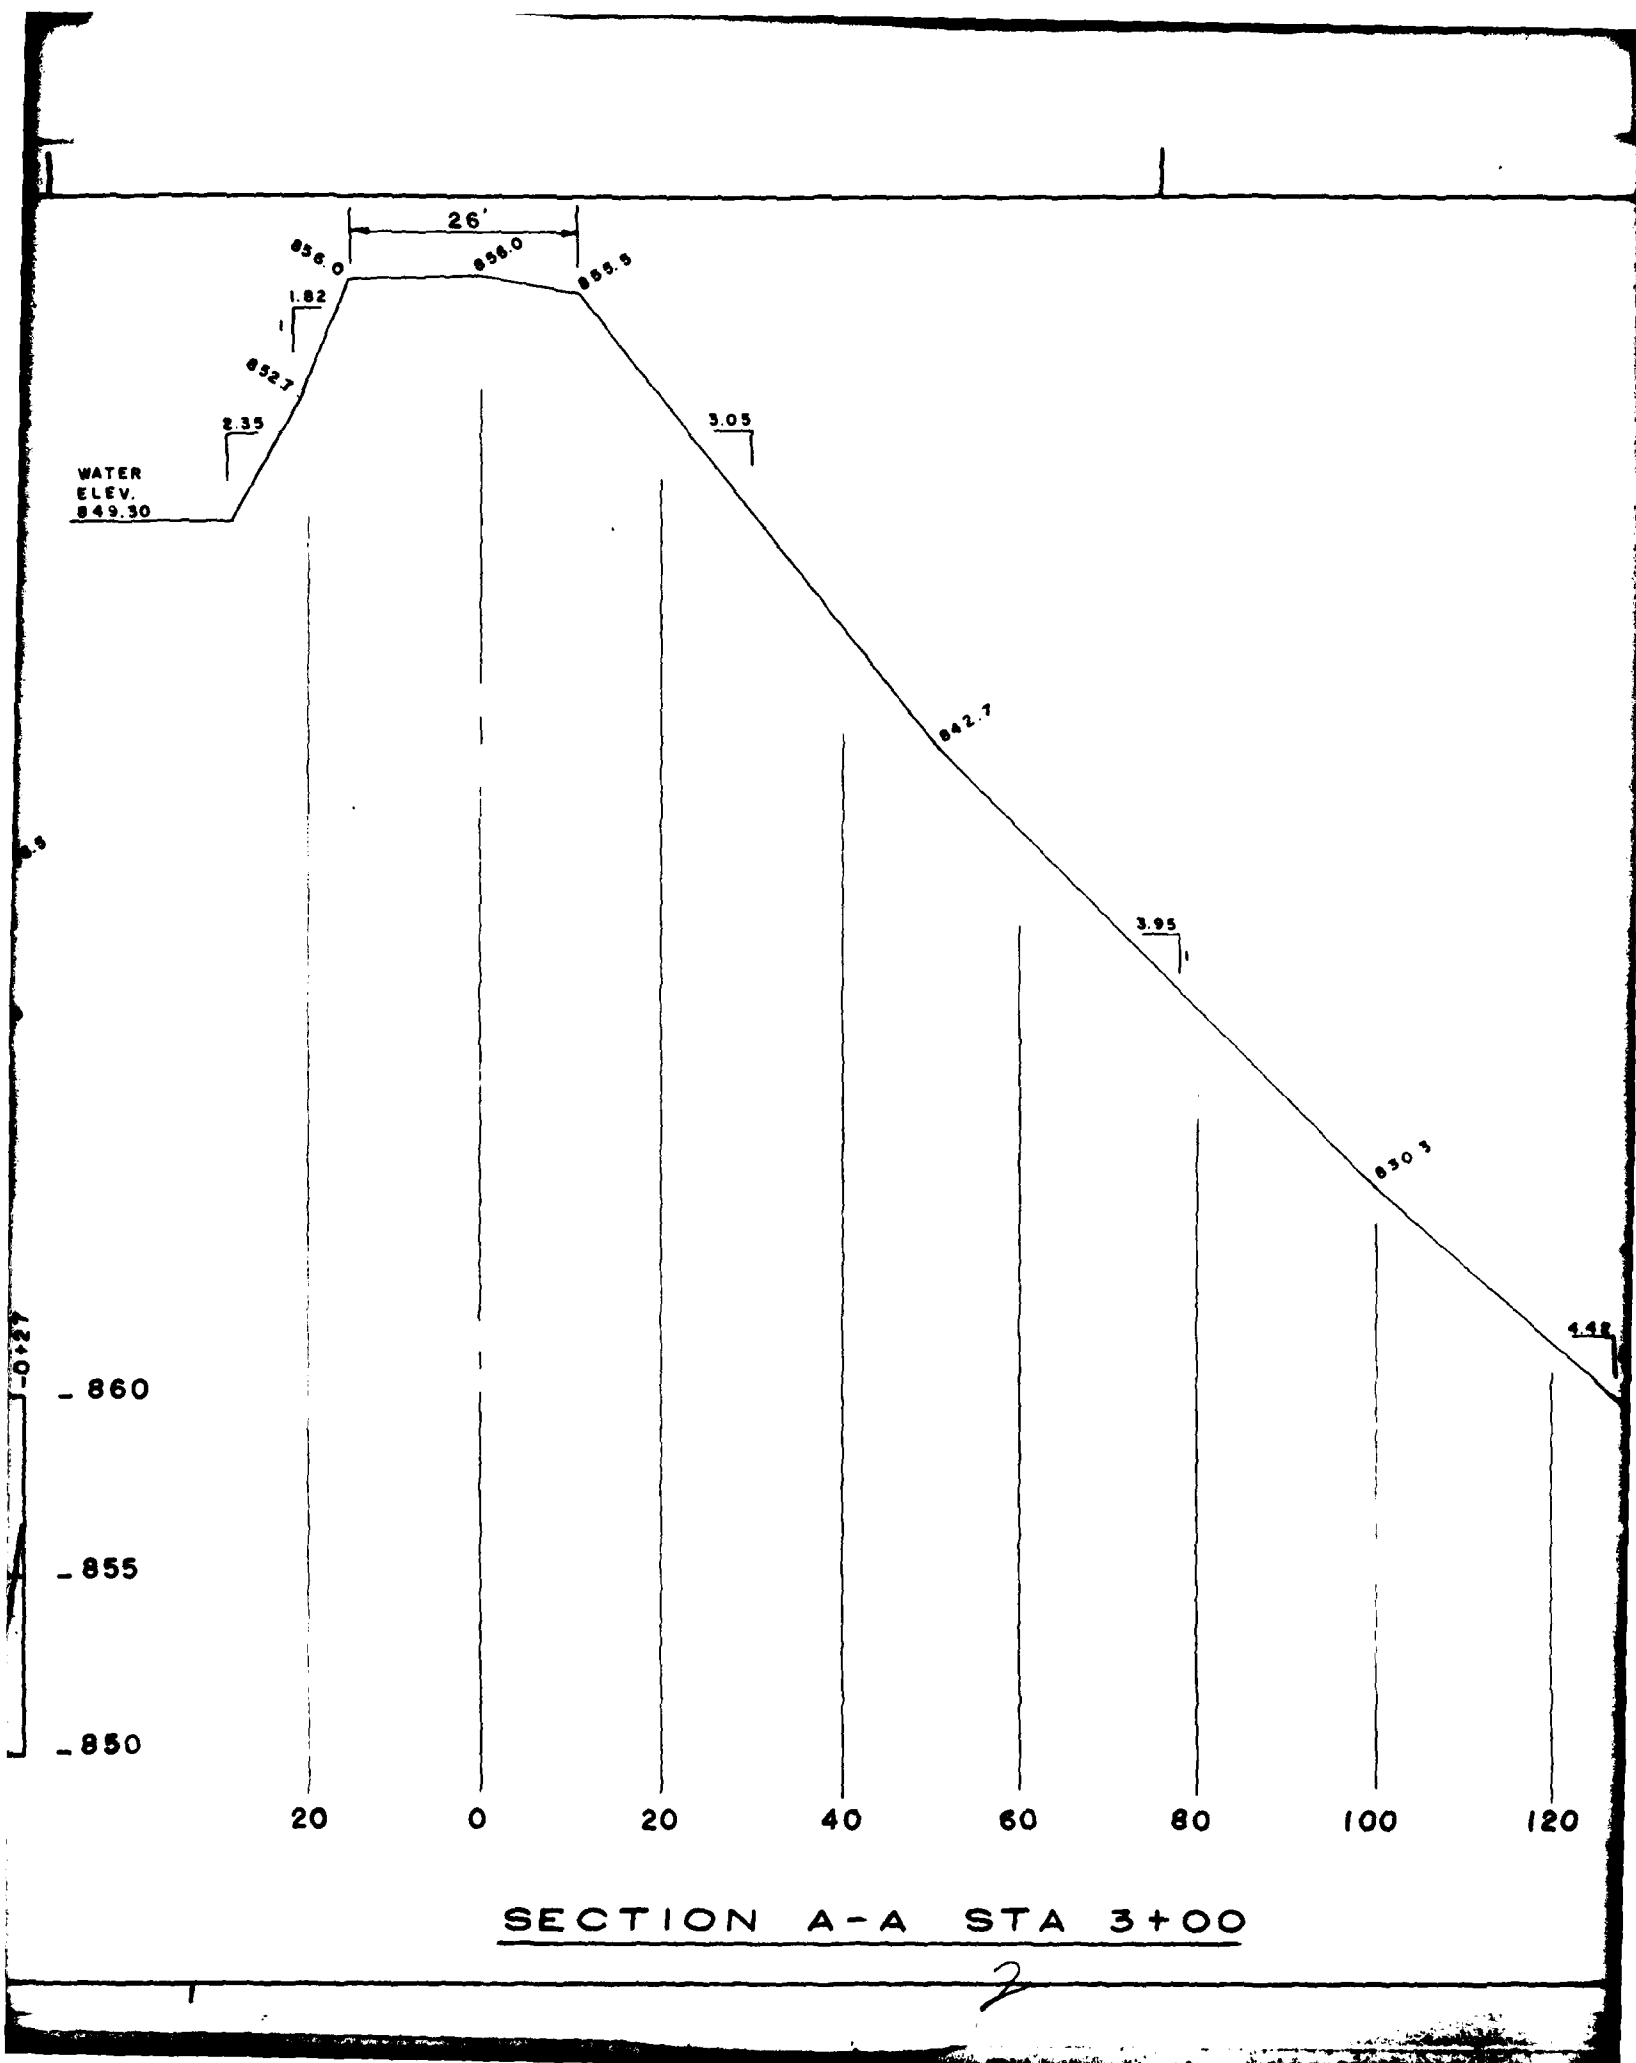
Sheet 3 of Appendix A

PLAN & PROFILE
